# REPLACEMENT RESERVE REPORT FY 2015

## WESTHAVEN HOA

# REPLACEMENT RESERVE REPORT

SPRINGFIELD, VIRGINIA

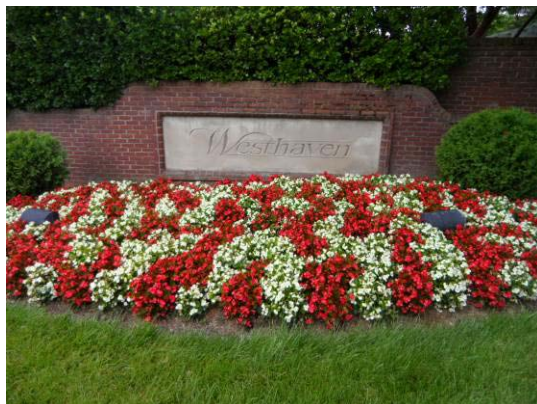
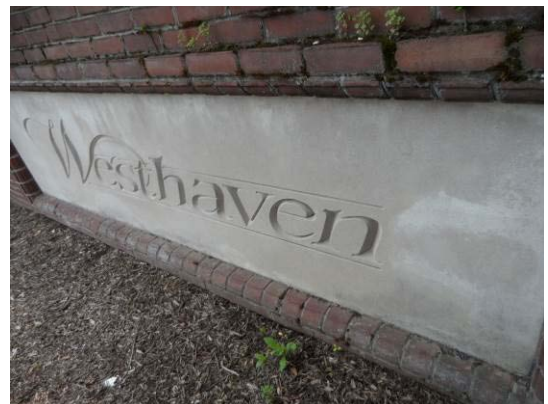
**Entry Monument and Signage.** The Association maintains an entry monument with signage and two entrance structures. The signage monument is made of brick with a concrete inset carded with the community's name. The concrete is in fair to good condition, with some staining noted. The brick wall contains some open masonry joints and loose and broken masonry units that should be addressed when the masonry privacy wall is restored in 2015.

We recommend repointing and replacement of defective areas of the masonry as needed. The Association may want to consider applying a coat of Siloxane or other appropriate breathable sealant to mitigate water penetration and further degradation of the masonry work. For additional information, please see the appropriate links on our web site at <http://mdareserves.com/resources/links/building-exterior>.

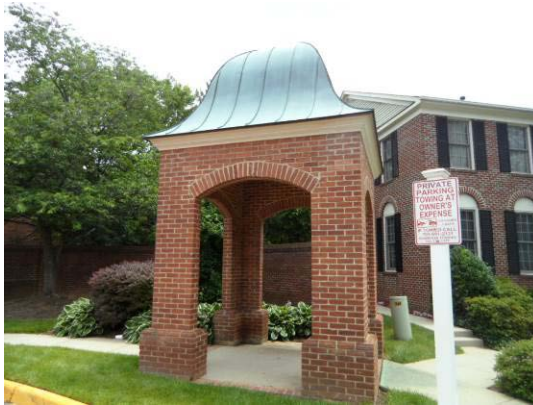
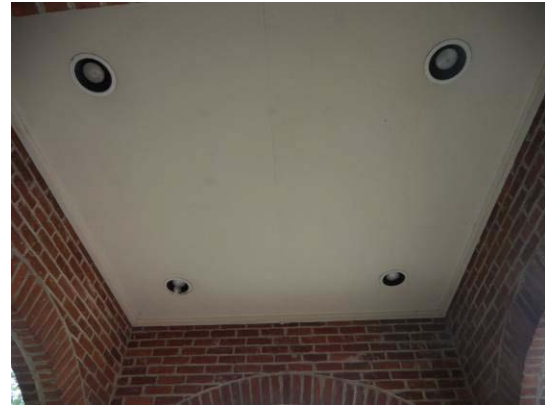
The two structures at one of the entrances are constructed of brick columns, standing seam metal roof and downlights in a drywall ceiling. The brick columns are long life items, but occasionally repointing will be required. We have included funds to replace the standing seam metal roof and ceiling/lighting system after 30 years of use. The metal roof may last longer with proper maintenance.

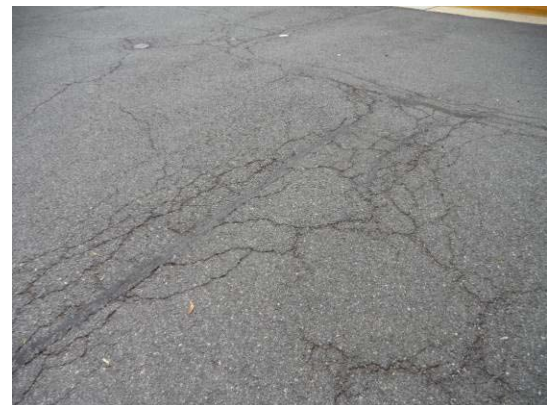
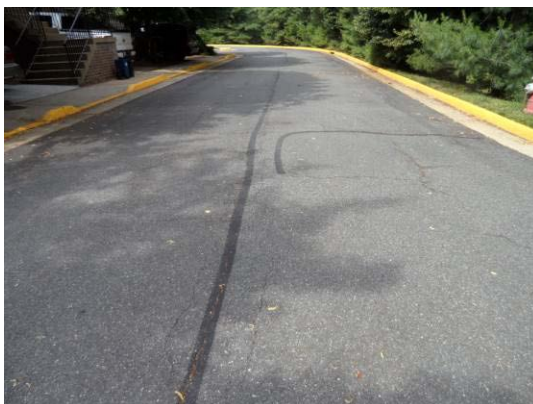
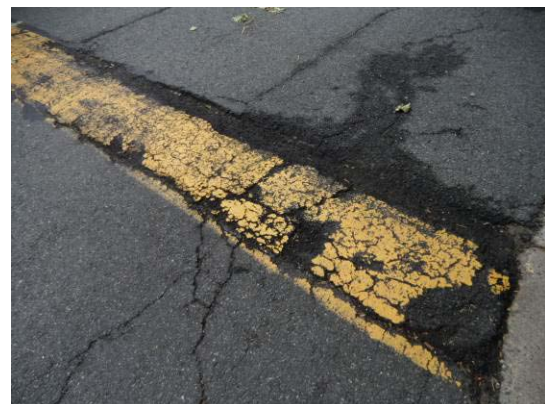
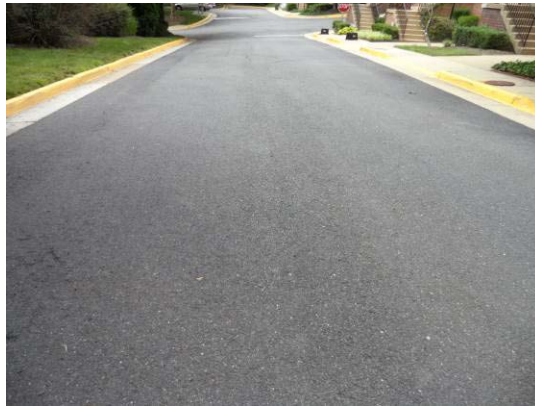
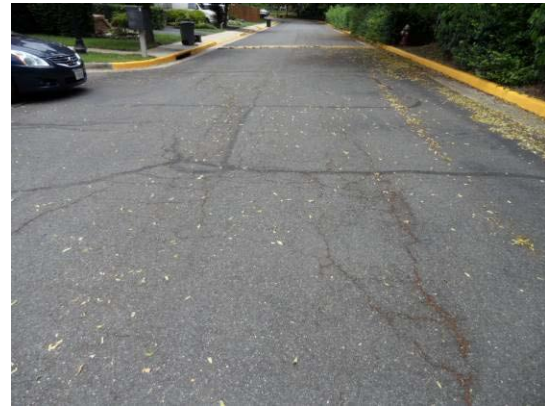
The asphalt pavement was milled and resurfaced in 2005, but has deteriorated to the point that it may need to be replaced in the next several years. Immediate repairs will be needed to extend the life of the asphalt two to three years.

As a rule of thumb, asphalt should be overlaid when approximately 5% of the surface area is cracked or otherwise deteriorated. The normal service life of asphalt pavement is typically 18 to 20 years.

In order to maintain the condition of the pavement throughout the community and to ensure the longest life of the asphalt, we recommend a systematic and comprehensive maintenance program that includes:

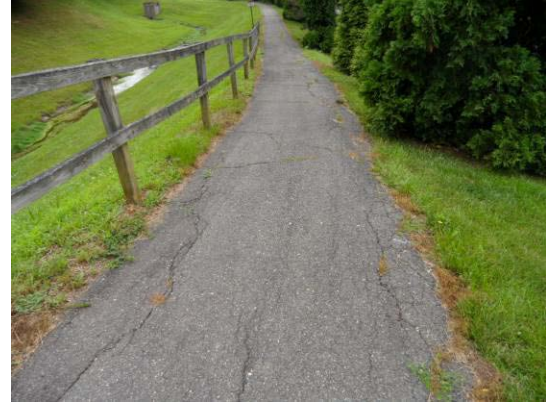
Asphalt paths are typically constructed on native soil. As a result, defects can begin to develop in a few years, leading to costly repairs or early replacement. Additionally, paths typically do not have proper edge confinement and support resulting in longitudinal cracking along the edges of the path. Compacted soil or gravel can mitigate this problem. Lastly, tree root damage is a common issue with asphalt paths, and some communities have had success with a process called root trimming.

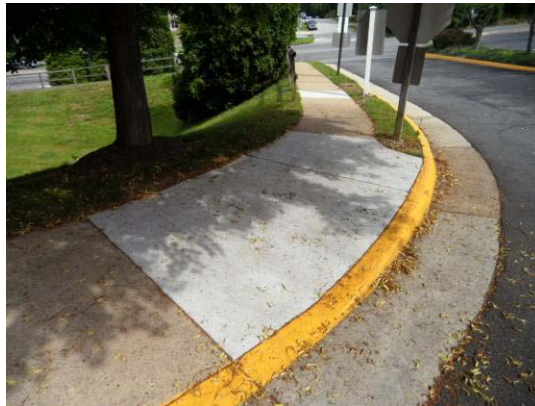
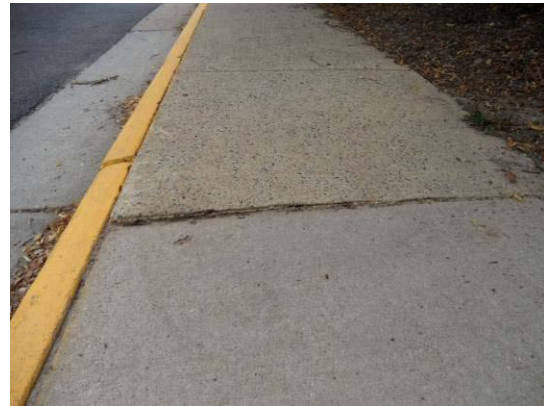
**Concrete Work.** The concrete work includes the community curbs, sidewalks, stairs, and other flatwork. The total quantity of sidewalk is 30,790 sf and the quantity of curb and gutter assemblies is 9,220 ft. We have modeled for curb replacement when the asphalt pavement is overlaid. The overall condition of the concrete work is good. We noted only one trip hazard. The Board walks the site at least annually to inspect for deficient concrete, and deficiencies are corrected in a timely manner. The most recent replacement occurred in May 2013. We noted many replaced sections of sidewalk and commend the Association on this proactive approach to concrete replacements.

The standards we use for recommending replacement are as follows:

- Trip hazard, ½ inch height difference.
- Severe cracking.
- Severe spalling and scale.
- Uneven riser heights on steps.
- Steps with risers in excess of 8¼ inches.

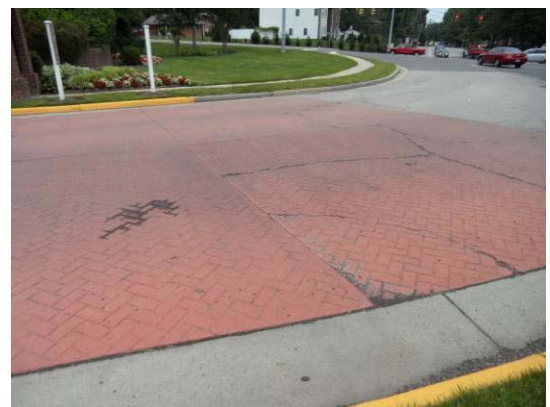
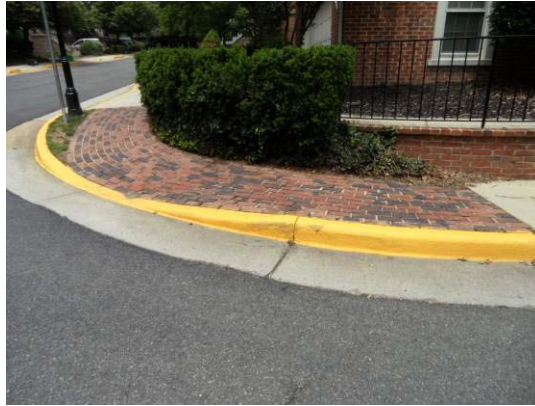
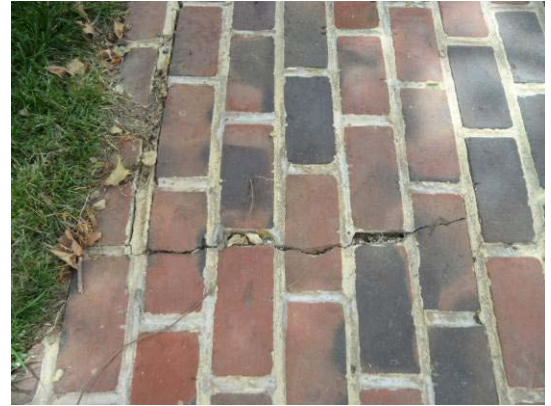
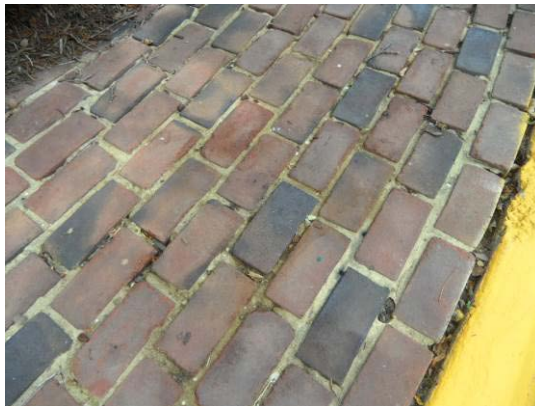
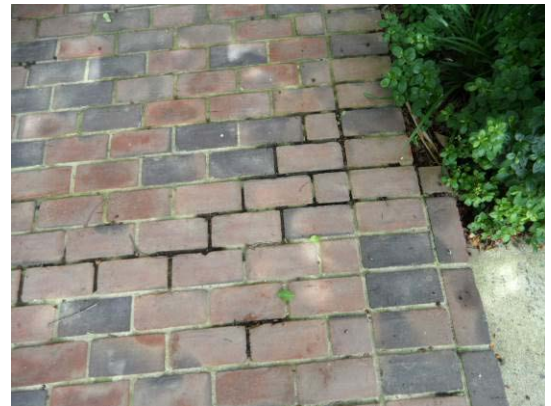
**Mortar Grouted Brick Pavers.** Brick pavers provide a solid, decorative, and renewable surface that is part of the community's sidewalk system. The overall condition of the unit pavers is fair with areas of defects consistent with the age of the installation.

The defects noted include the following:

- Cracking. There are multiple cracked pavers, some of which are creating trip hazards.
- Settlement. We identified areas where pavers have settled due to a failure of the base under the pavers. This settlement has resulted in an uneven surface that can pose a trip hazard.
- Delamination. The surface on a number of the pavers is separating from the body of the brick resulting in rough surfaces that form a trip hazard.
- Failed Grout. The grout installed between the bricks is failing. Failed grout will allow water to penetrate below the surface washing away the base materials.

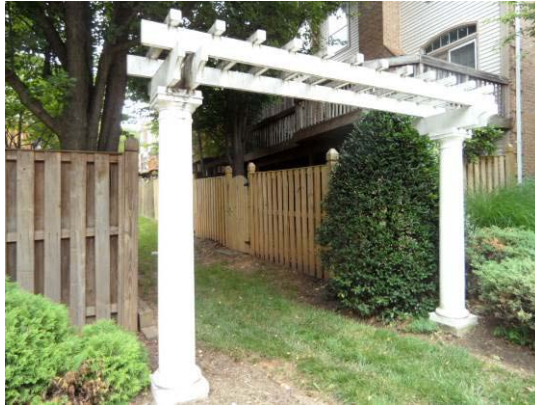
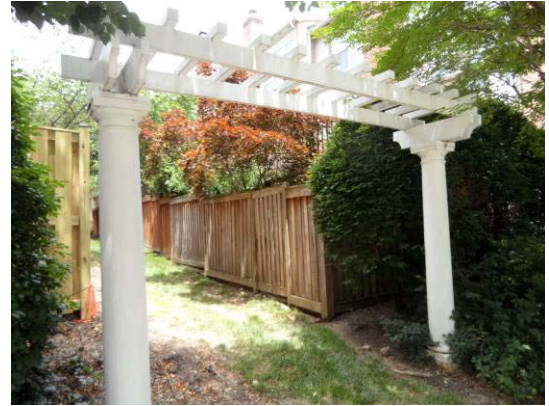
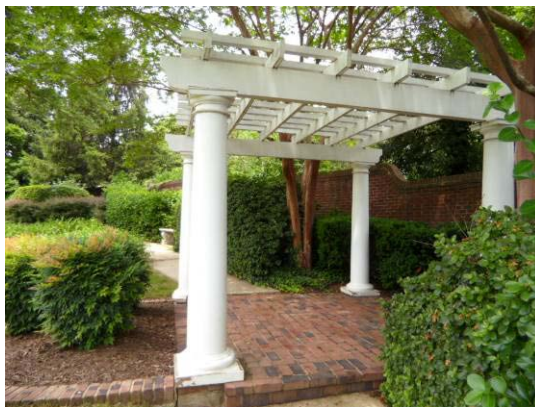
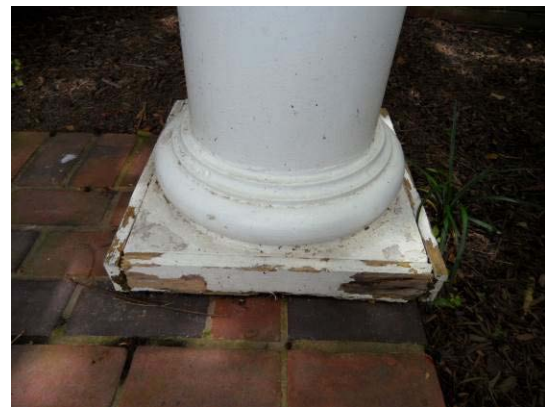
**Trellises.** The community contains two smaller trellises and one larger trellis. The trellises were originally wood, but the columns were replaced in 2005 with a Permacast® product made of fiberglass. The components that are still wood will need to be sanded, primed, and painted periodically to prevent the wood from rotting.

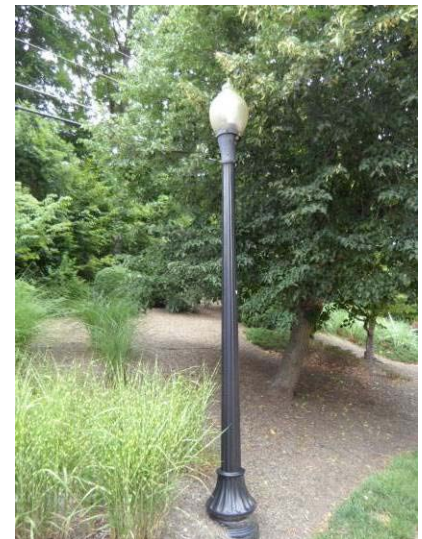
**Site Lighting.** The Association is responsible for the operation of the facility's streetlights, which consists of 16 poled streetlights. The lighting system was not on at the time of our site visit. We understand that the lighting system is in operating condition. The condition of the light poles was good with no significant noted defects.

This study assumes replacement of the light fixtures with poles every 35 years. When the light poles are replaced, we assume that the underground wiring will also be replaced.

In addition, new technology such LED and LIFI among others should be evaluated when considering replacement.

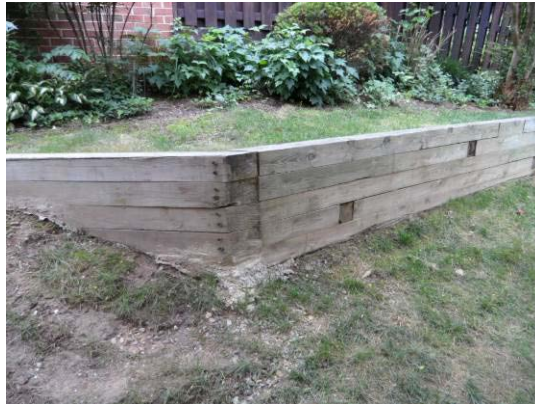
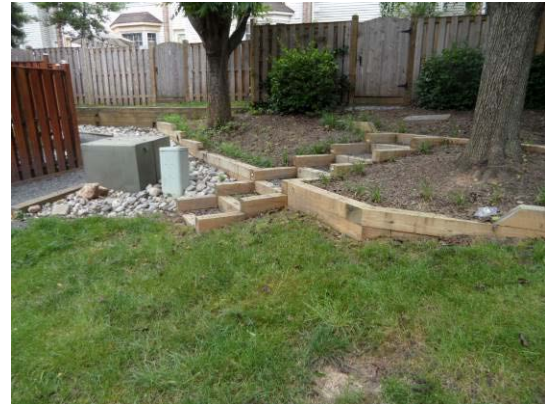
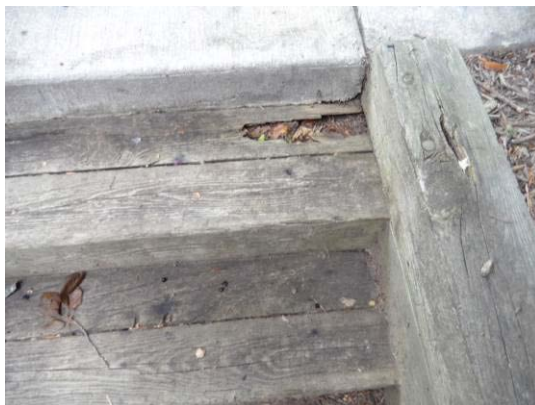
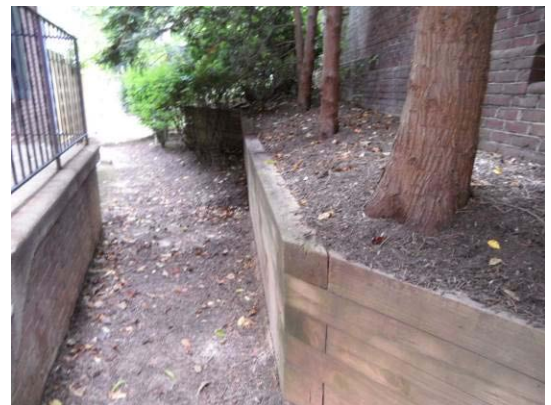
**Retaining Walls.** The Association maintains multiple wood and decorative concrete block retaining walls. The retaining walls are in mixed condition with light leaning, deterioration, and rot. Many of the walls are original, but some have recently been installed to address drainage and erosion issues.

Wood retaining walls will experience rot and decay over time and partial replacement of defective wooden members is often possible in the early stages of decay. Eventually however, these walls will require replacement. Wood retaining walls can have a useful life of 25 to 35 years. We have programmed funds to replace 20% of these walls every 5 years to reflect the varying condition of the walls and the incremental nature of this work.

When and if it becomes necessary to replace the wood retaining walls, we recommend the Association consider one of the segmental block retaining wall systems. These systems are very low maintenance. If over time the wall experiences movement, sections of the walls can be re-stacked at a very small portion of the cost of a new wall. Segmental block retaining walls can have a service life of 80 years or more. As a general source of information about retaining walls, we offer several links from our website at <http://mdareserves.com/resources/links/site-components>.

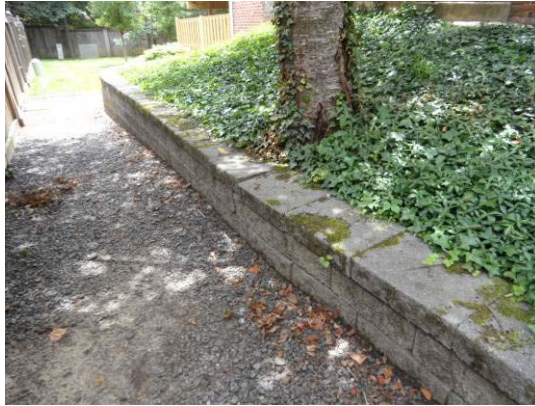
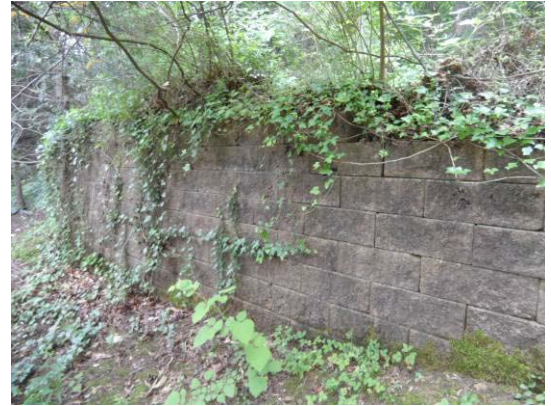
Concrete block masonry walls can have an extended useful life of 40 years or more, and if stable, may only require periodic restacking and localized repair. This study assumes that maintenance will be performed incrementally as needed.

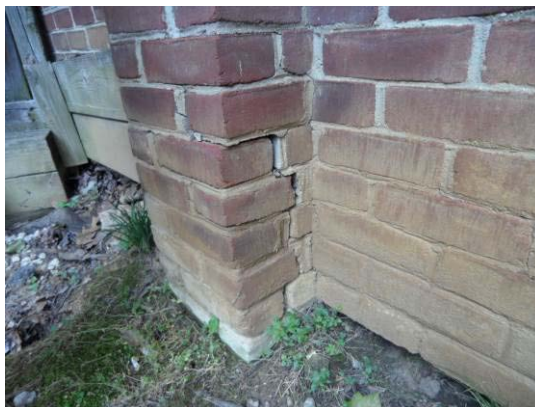
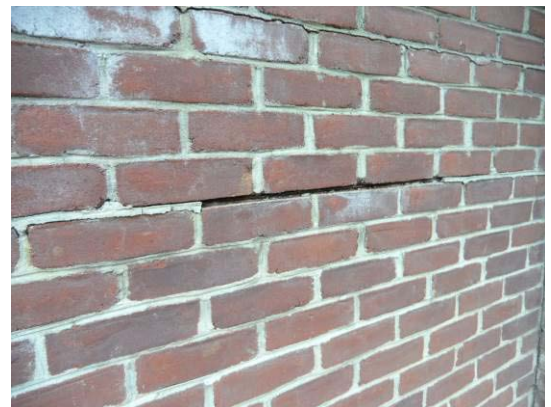
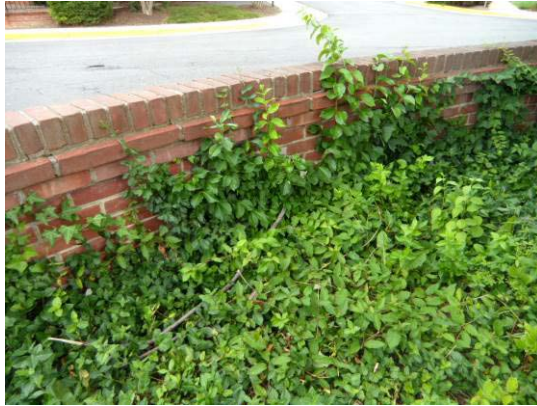
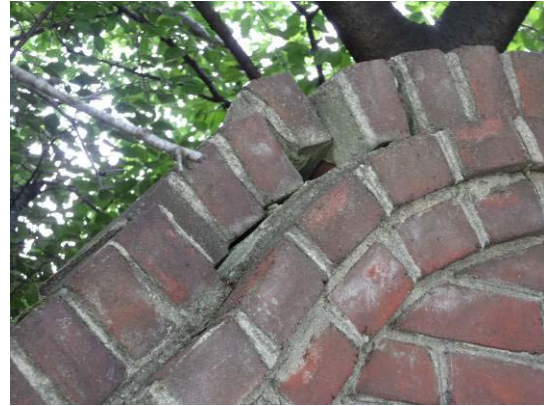
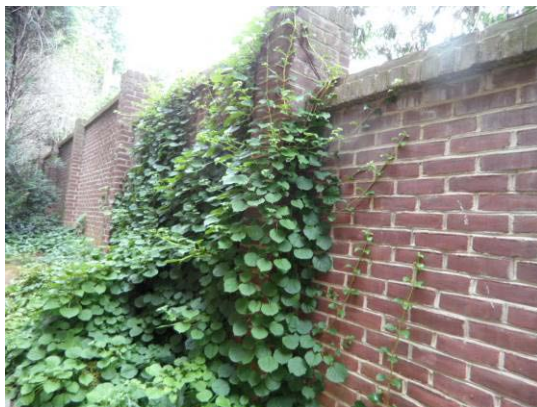
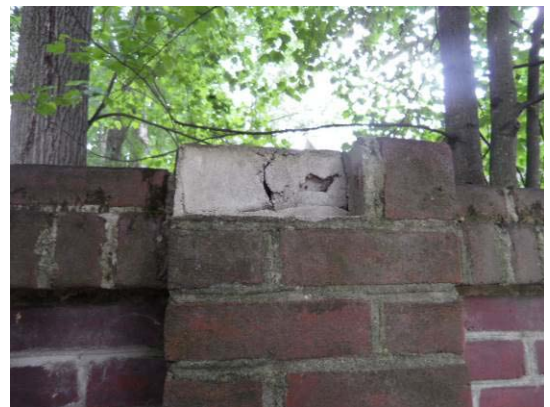
**Brick Privacy Walls.** The Association maintains 2,100 lineal feet of brick privacy wall that varies in height from 3' to 10'. The Association is expecting to undertake a significant restoration project in 2015 to include repairing the wall. The scope of the project will be to remove all vegetation (including ivy), pressure wash the bricks, replace all damaged and missing bricks, and re-point failed mortar on both sides of the walls. The Association obtained price quotes in 2012 to restore the wall. The bids ranged from \$54,000 to \$82,000 plus an additional \$10,000 for pressure washing. Once this restoration is complete, the wall will need to be repointed and repaired as needed approximately every 10 years.

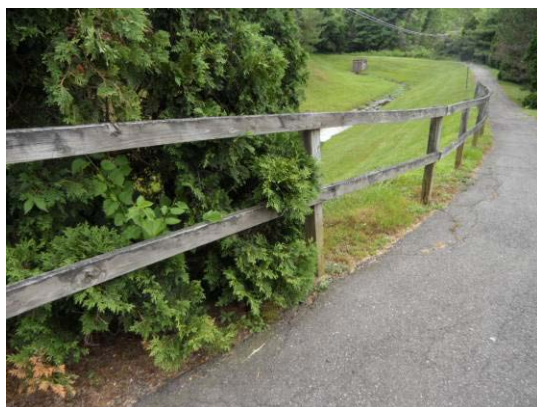
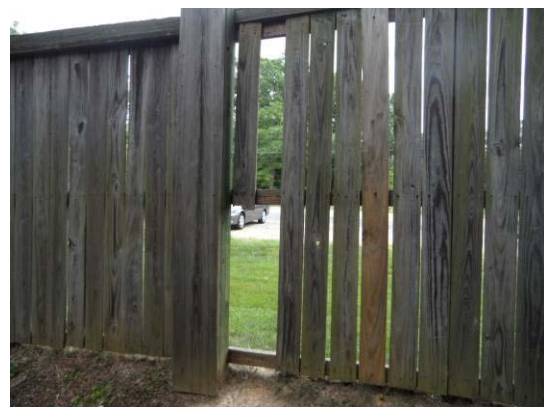
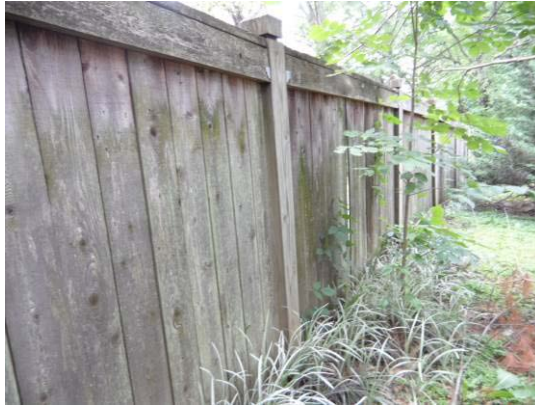
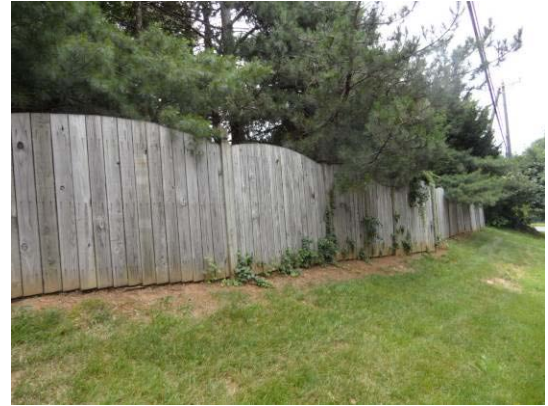
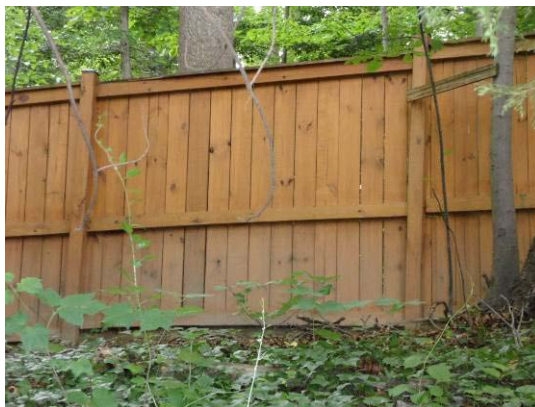
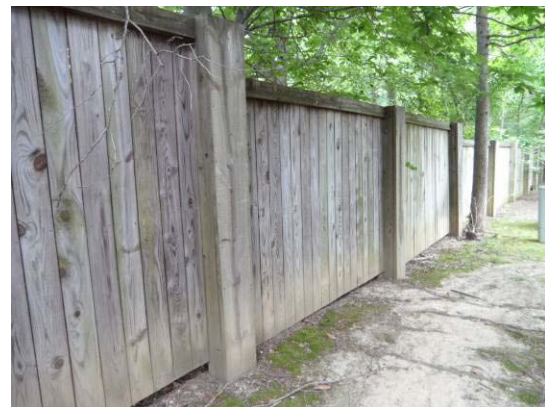
**Fencing.** The Association maintains wood fencing that is in mixed condition. Some of the fencing that backs up to neighboring communities appears to be newer and has many years of remaining life. The fencing along Old Keene Mill Road is aging and should be budgeted for replacement in the next several years. The two-rail fencing near the storm water management pond has reached the end of its life. Fencing systems have a large number of configurations and finishes that can usually be repaired as a maintenance activity by replacing individual components as they become damaged or weathered. Replacement of sections damaged by vandalism may be required before the fence is replaced in full, such as the broken section shown below.

Protection from string machine damage during lawn maintenance can extend the useful life of some fence types. Protection from this type of damage is typically provided by applying herbicides around post bases or installing protective sheathing.

Pressure treated wood fencing should be cleaned and sealed every year or two. Typically the least cost fencing option, this type of fence can last 15 to 20 years if maintained properly.

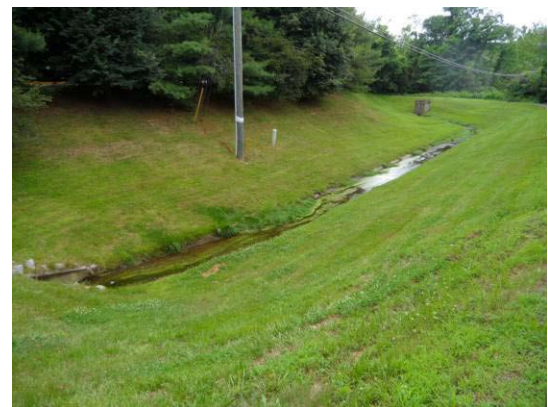
Estimates of cost and the frequency of dredging ponds are a function of many variables, including the volume of the pond, the siltation rate, the nature of the material being removed, the method of removal, and the haul distance to a site that will accept the spoil material. Most of this information is unknown and must be assumed for the purpose of reserve study planning. The siltation rate and cost of periodic dredging are speculative, varying greatly depending on local conditions.

As a rule of thumb, dredging should be performed when approximately one-third of the volume of the pond has been filled with silt. In the absence of accurate information about the original depth of the pond and the local siltation rate, we have assumed that it will be necessary to remove one cubic yard of material over a third of the pond area every 20 years. We have assumed that the material being removed is free of heavy metals and hydrocarbons, and that it will be accepted as fill at a local landfill. A more accurate prediction of cost and cycles will require a hydrologic analysis and testing, which is beyond the scope of our study.

Because of the significant cost of this work, it is recommended that the Association undertake studies to refine the assumptions of this study.

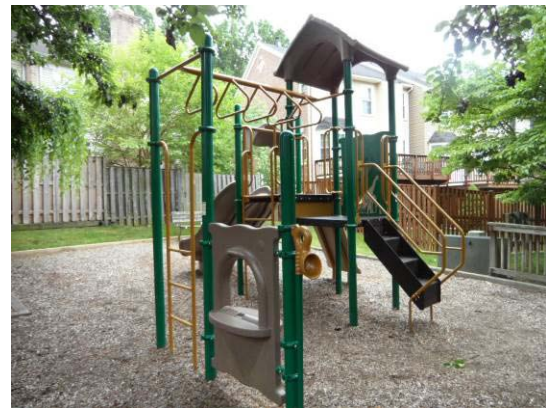
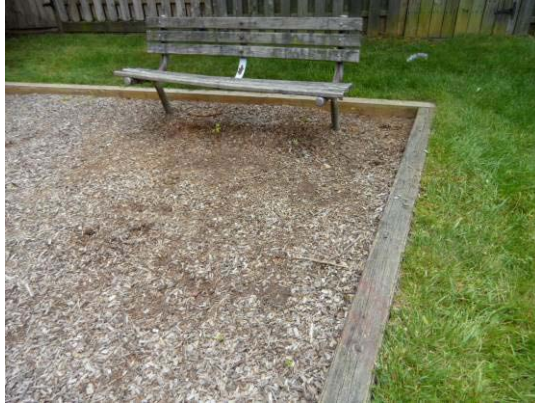
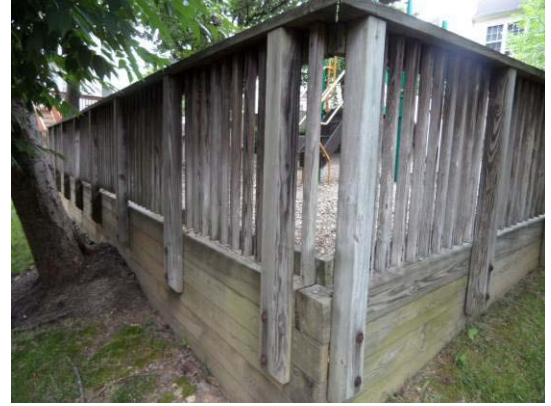
**Tot Lot.** There is a single tot lot on the property with children's play equipment. The area has a wood mulch play surface enclosed by a wood border. The play equipment was replaced in 2007 or 2008 according to Mr. Carr. Individual components are in need of repair, but the overall condition of the play structure is good. The wood border is aging except for one of the sides with a newer piece of lumber. The retaining wall is in good condition, but the railing is aging and may need to be replaced sooner. Annual inspections should be performed to ensure an adequate level of mulch and to identify necessary repairs. The Association's contract with the landscape company includes mulch for the tot lot.

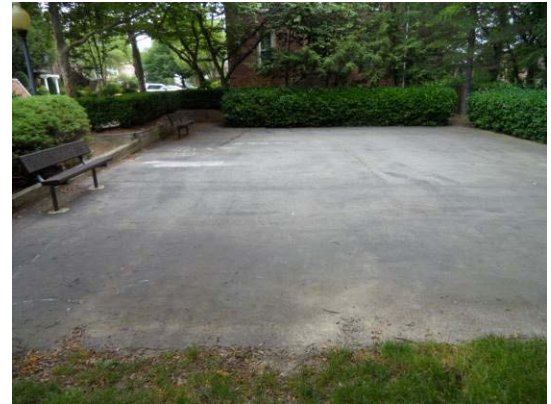
**Multipurpose Court.** There is a 40' x 50' asphalt area that was initially envisioned as a basketball court but is now used as a multipurpose court. The asphalt is in fair condition, with some cracks that should be filled when the asphalt pavement is crack filled and seal coated in 2015. The court contains a single powder coated metal bench that is considered a minor item. The small retaining walls are included in the "wood retaining wall" item.
